Superfund

Radiation - Standard Precision, Inc. (Formerly
Wichita, Kansas)

Figure 3
Gamma Survey Results Map

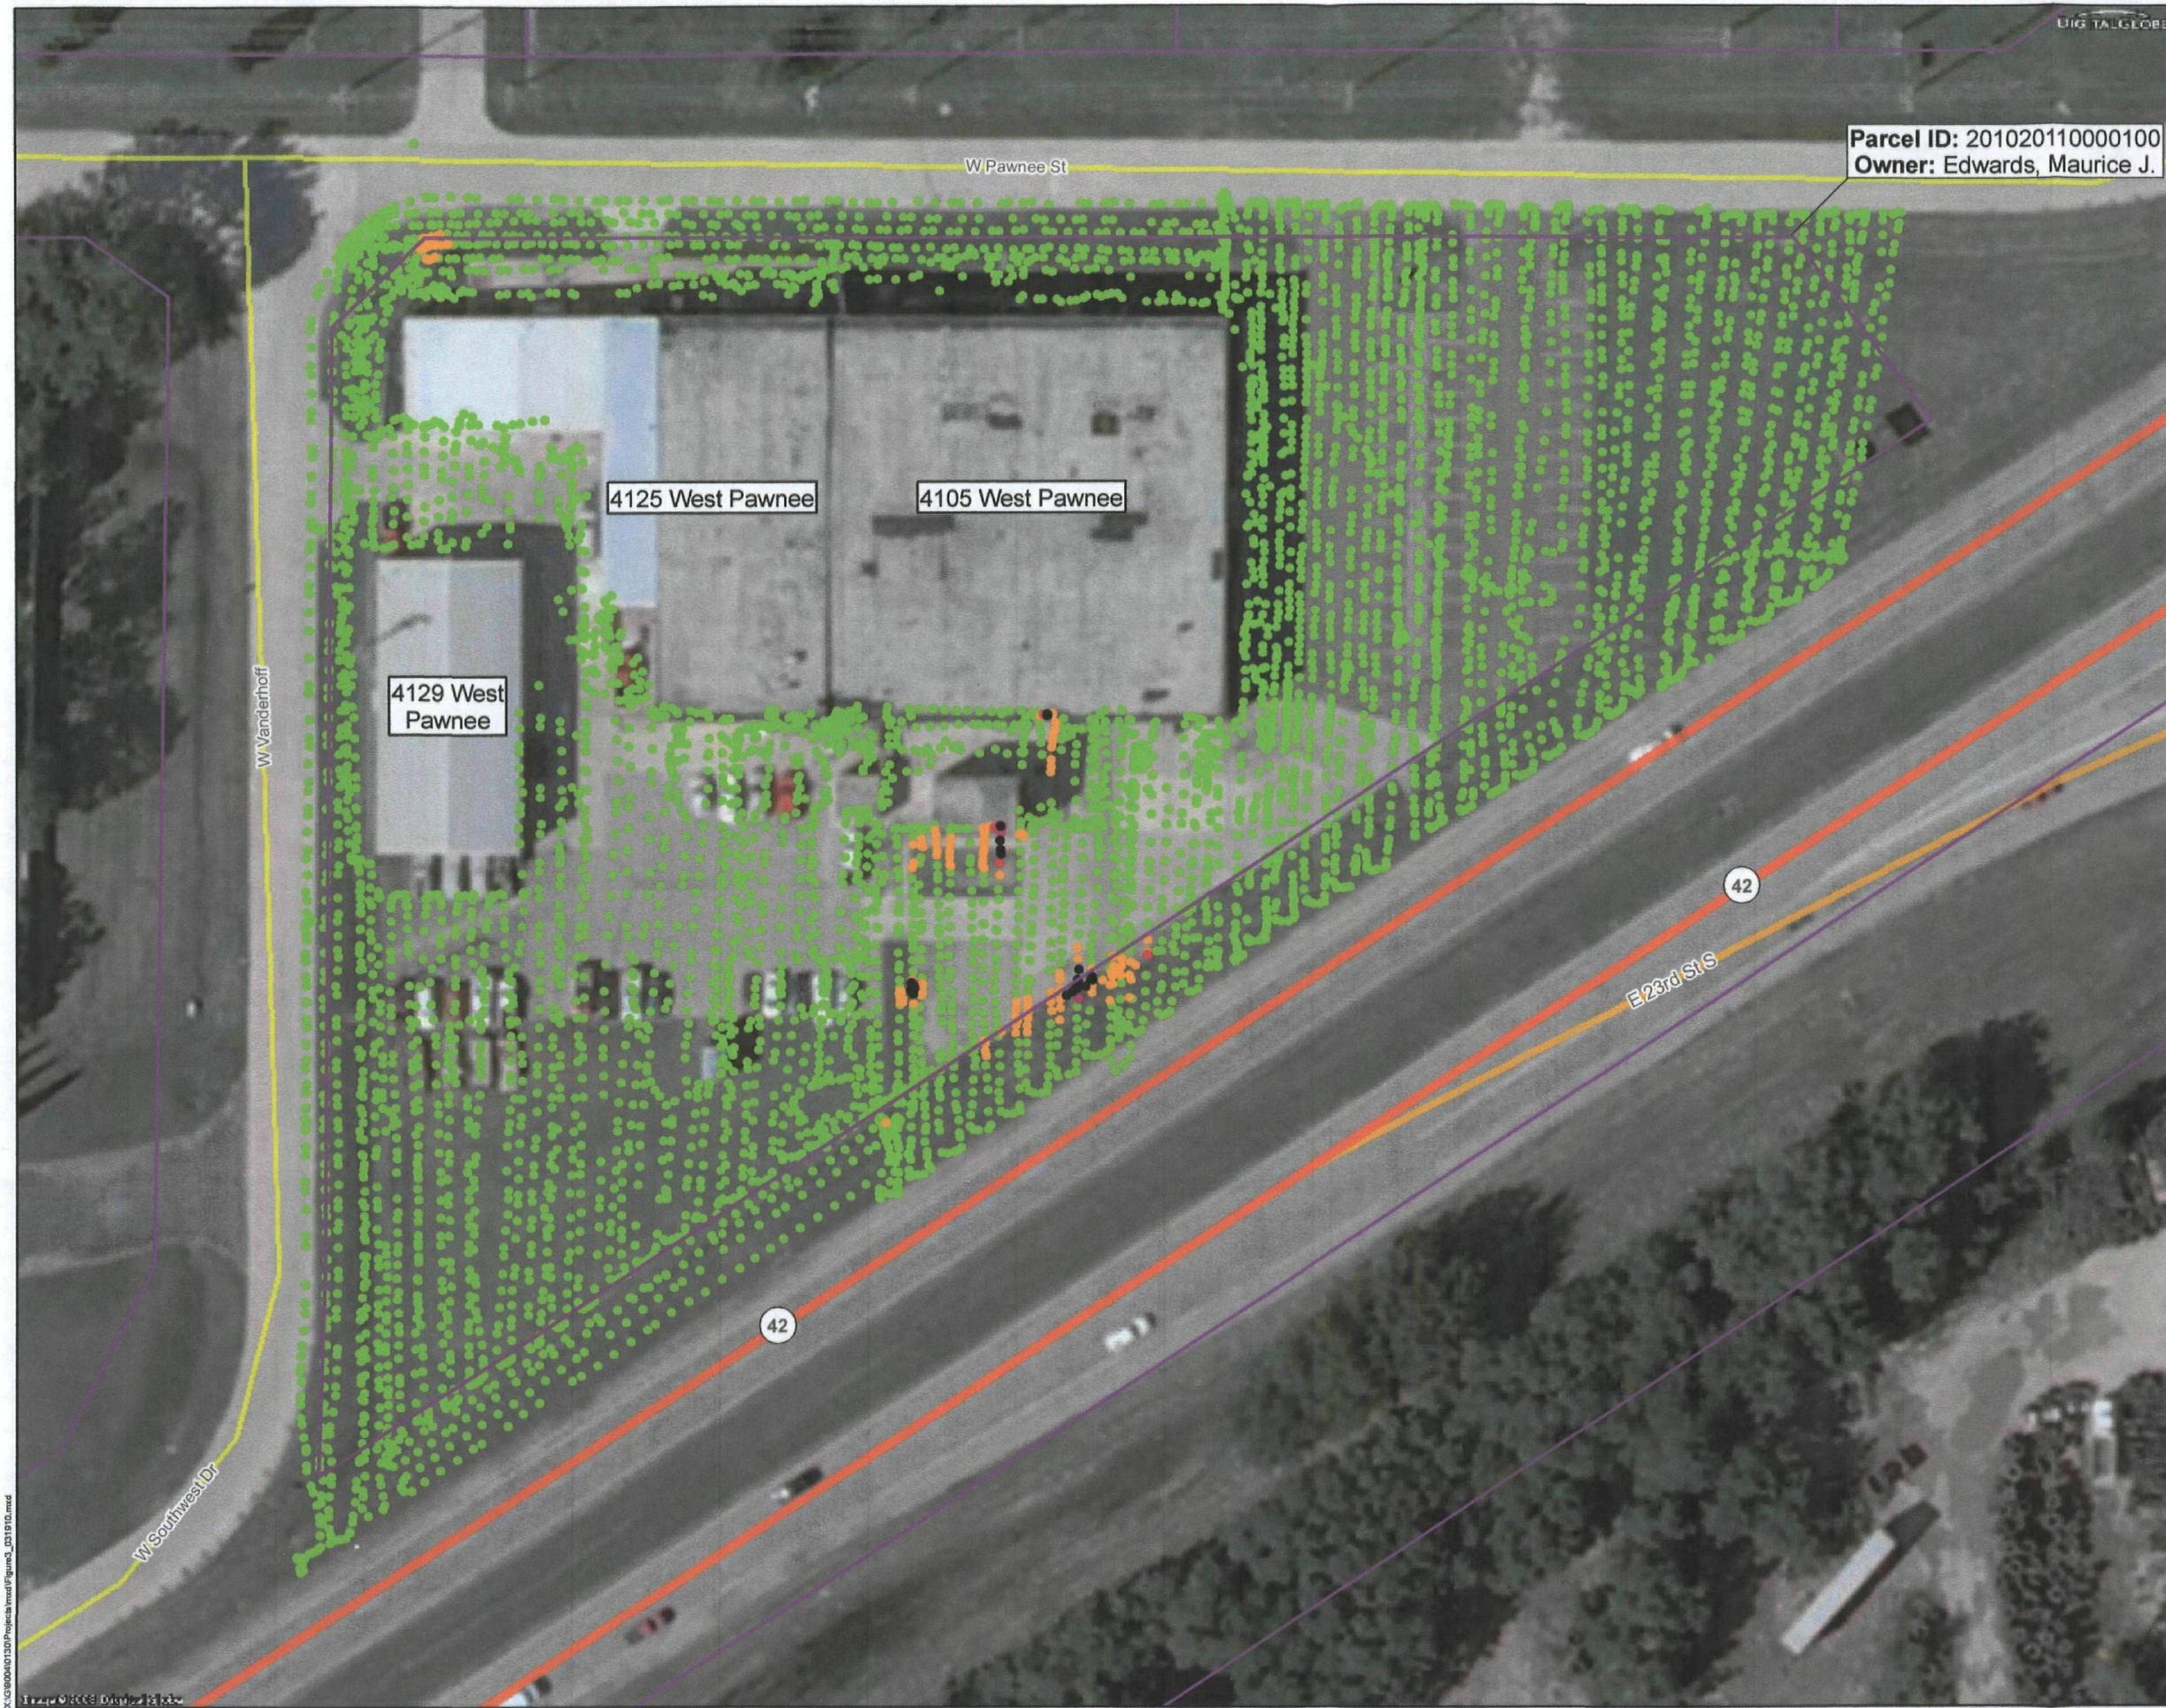
- < 21,427 cpm
Below Investigation Level
 - 21,427 - 42,854 cpm
Investigation Level to 2x Background
 - 42,854 - 57,139 cpm
2x Background to 3x Background
 - 57,139 - 71,423 cpm
3x Background to 4x Background
 - > 71,423 cpm
> 4x Background
- State Highway
- Major Road
- Street
- Parcel Boundary
- cpm Counts per minute

Notes: Measurements were collected using a Ludlum 3x3 detector.

The Investigation Level is the mean of background readings plus 10 times the standard deviation of the background readings. Areas that exhibited gamma activity above the Investigation Level were subjected to additional investigation following the initial surface soil gamma survey.
